# New York State Department of Transportation

## Yellow Flag NB22U4W003

**BIN: 1065318**

Location: Span 164, Girder G14 bearing at Pier 164, (above the shielding platforms installed by contractor over the parking lot between 38th and 39th Street).

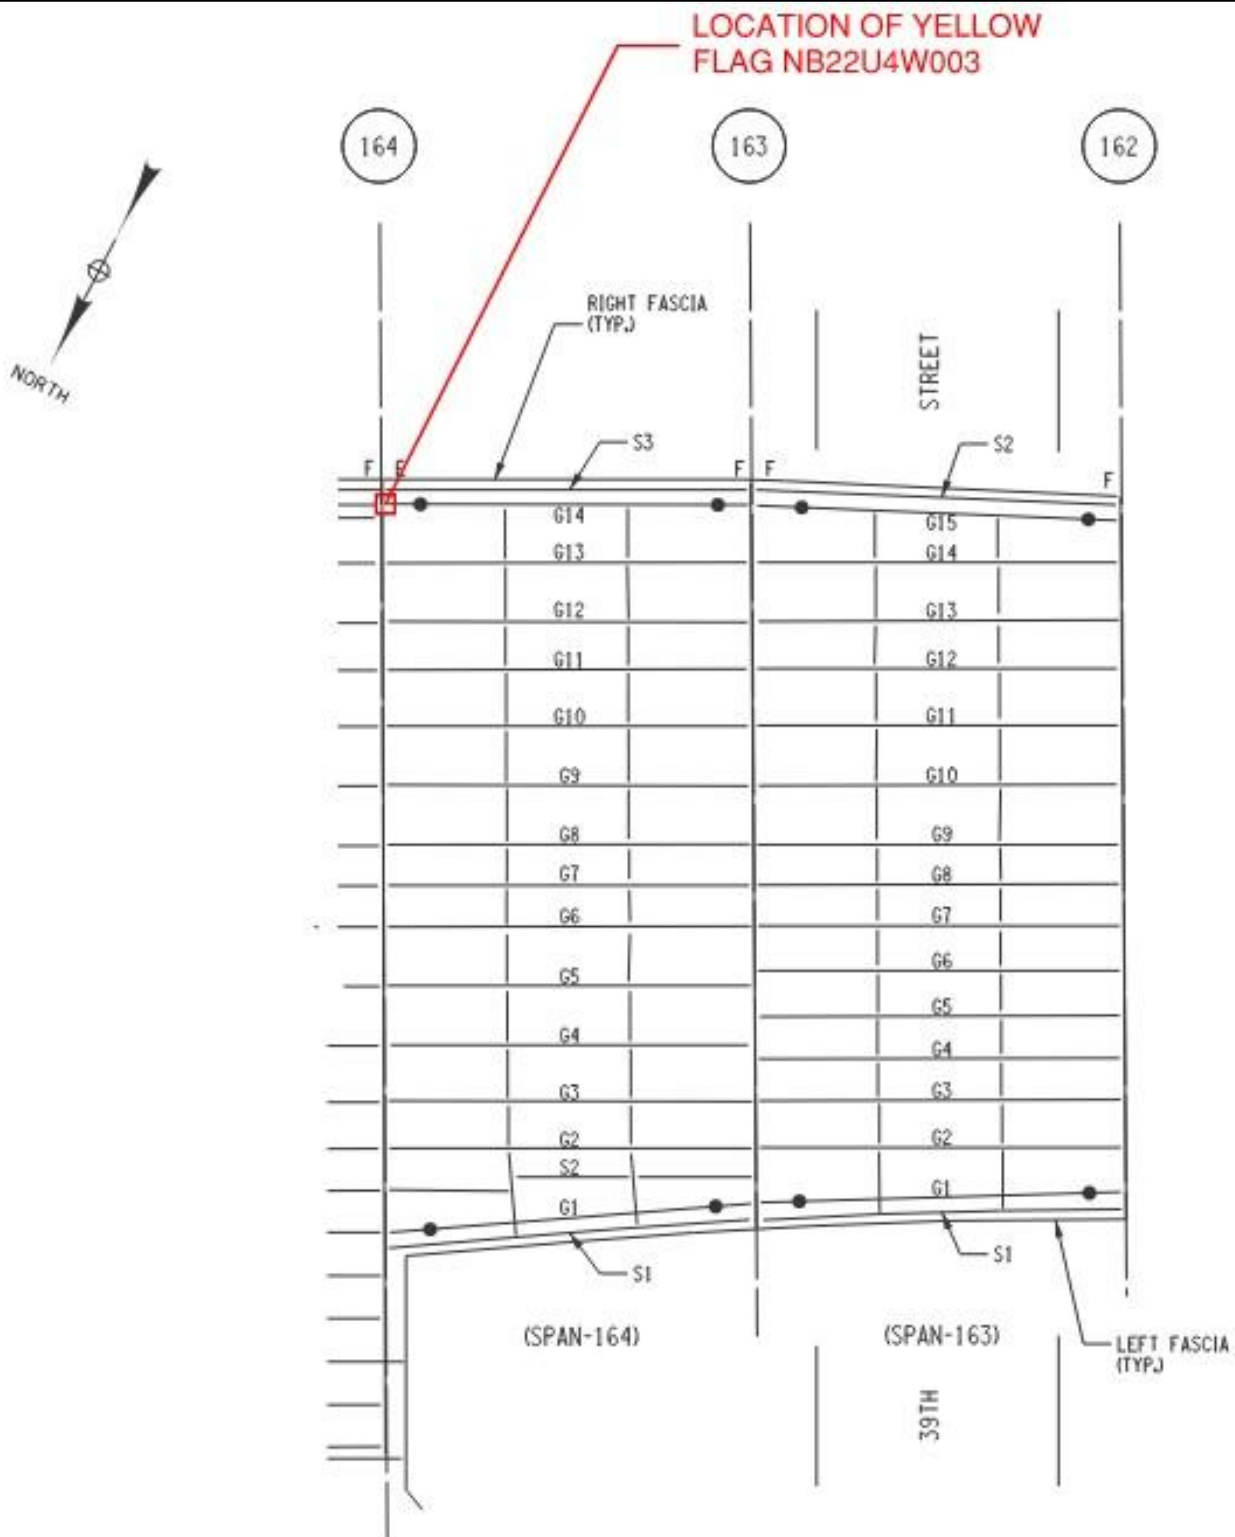
Photo Number: 1

**Attachment Description: Yellow flag location plan**

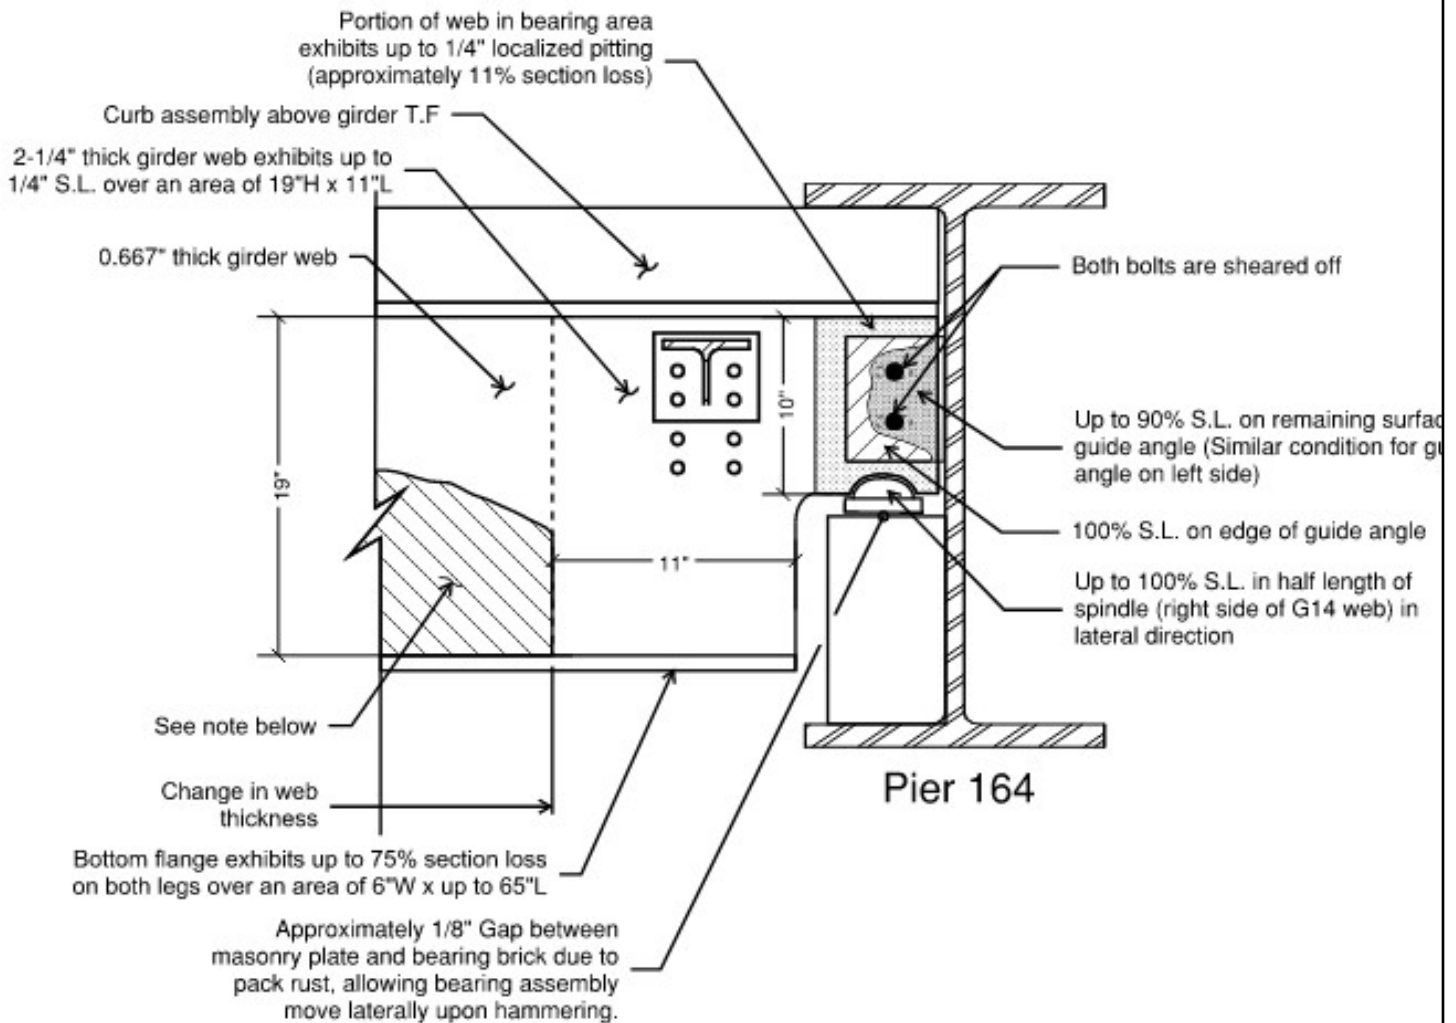
Photo Number: 2

Additionally, the web portion of the girder adjacent to the bearing area also exhibits 1/4" deep section loss over an area of 19"H x 11"L (11% section loss). The bottom flange on both sides of the web exhibits up to 75% section loss over an area of 6"W x up to 65"L. (refer to Yellow Flag Condition Sketch Photo #2 for more details)

Girder web beyond limit of additional web thickness, exhibits up to 95% section loss over an area of 168" L x 12"H with several holes in web with size of up to 7"L x 2"H.

**SPAN 164, GIRDER G14 BEARING**  
**(LOOKING LEFT)**  
**N.T.S**

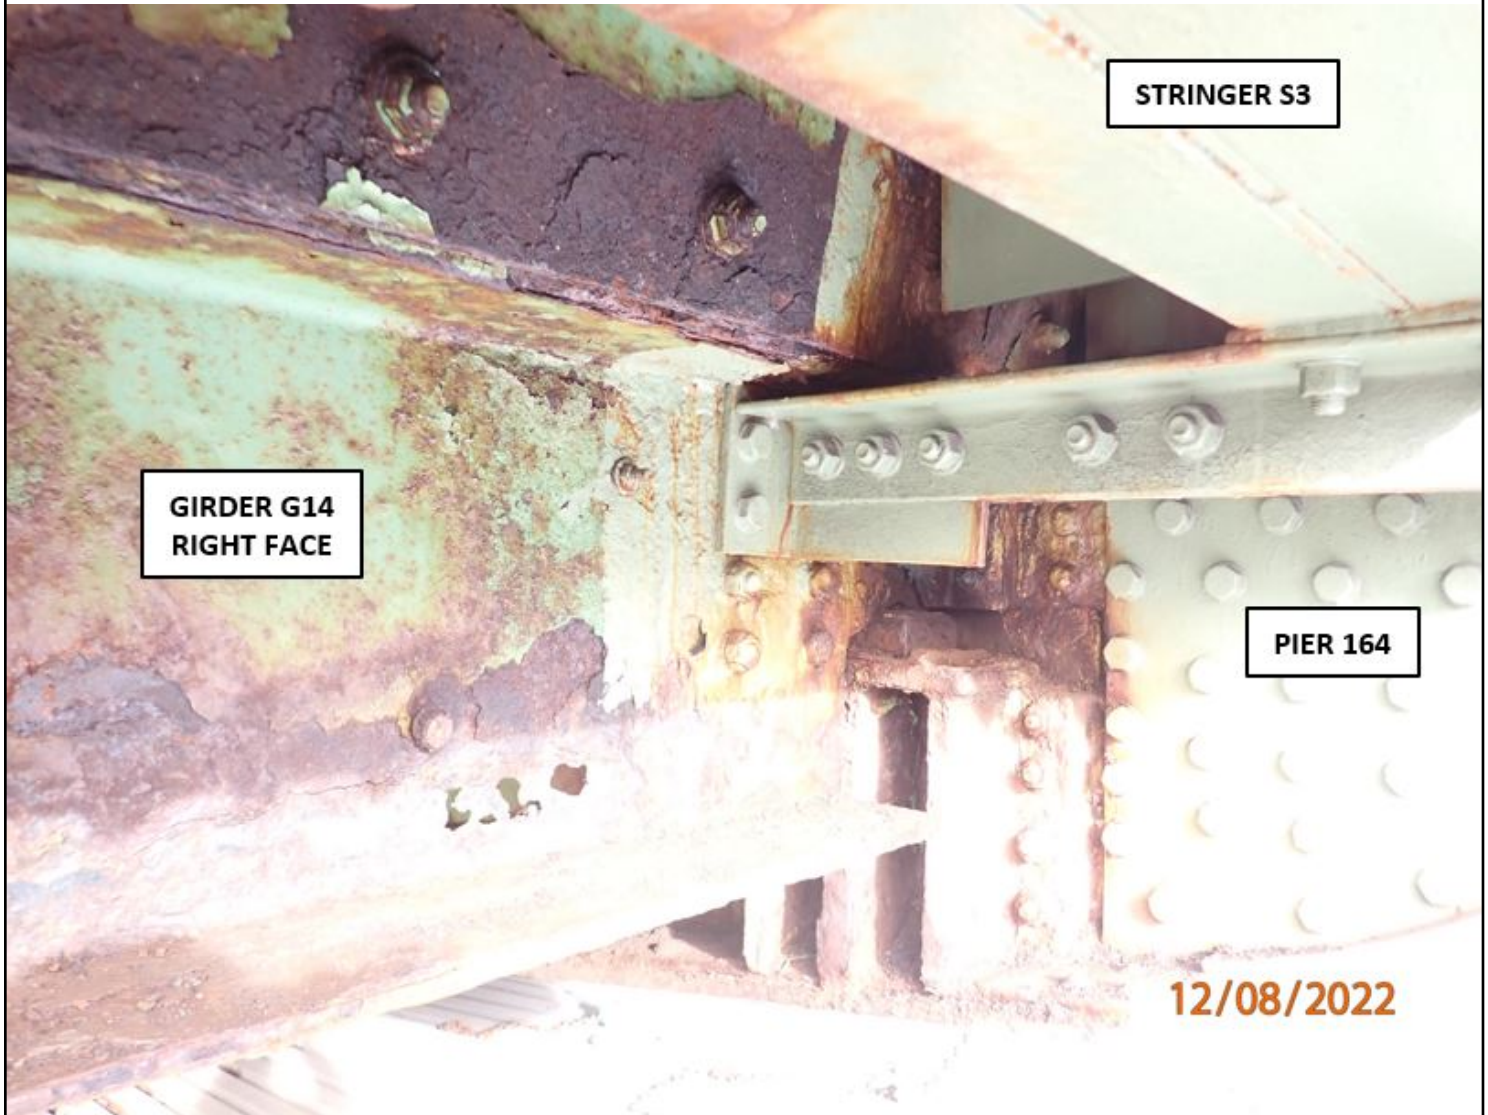
Photo Number: 3

**Attachment Description:** General view of Girder G14 in Span 164 at Pier 164. Looking End and Left.

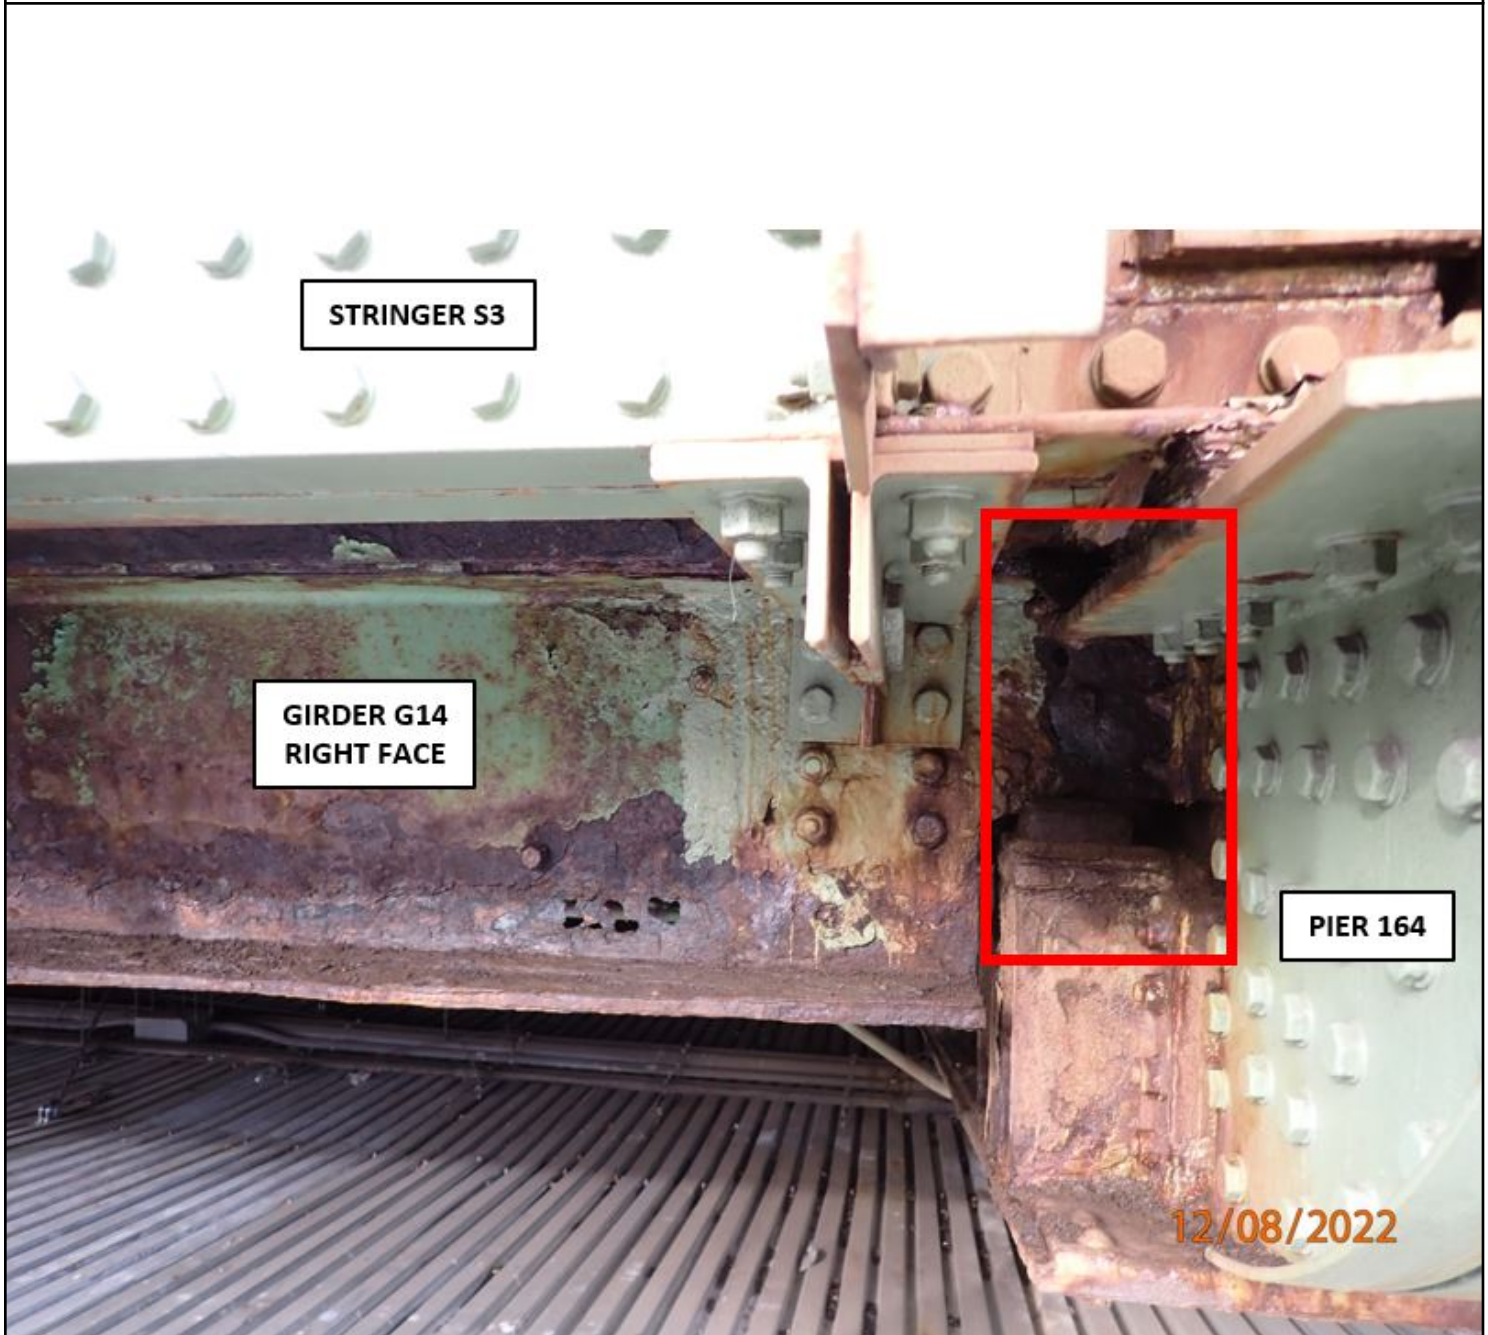
Photo Number: 4

3. At a distance of 19" from the Girder G14 end, the thickness of the Girder G14 web decreases from 2-1/4" to 0.667" thick. The web beyond the 19" from girder end, exhibits severe section loss (up to 95% section loss) over an area of 12"H x 168"L along the bottom flange, with several large holes up to the size of 7"L x 2-4"H (See Photo No. 4).

**Attachment Description:** General view of Girder G14 bearing in Span 164 at Pier 164. Looking Left. (Note the girder web beyond the bearing exhibits up to 95% section loss, over an area of 12" H x 168"L along the bottom flange with several large holes).

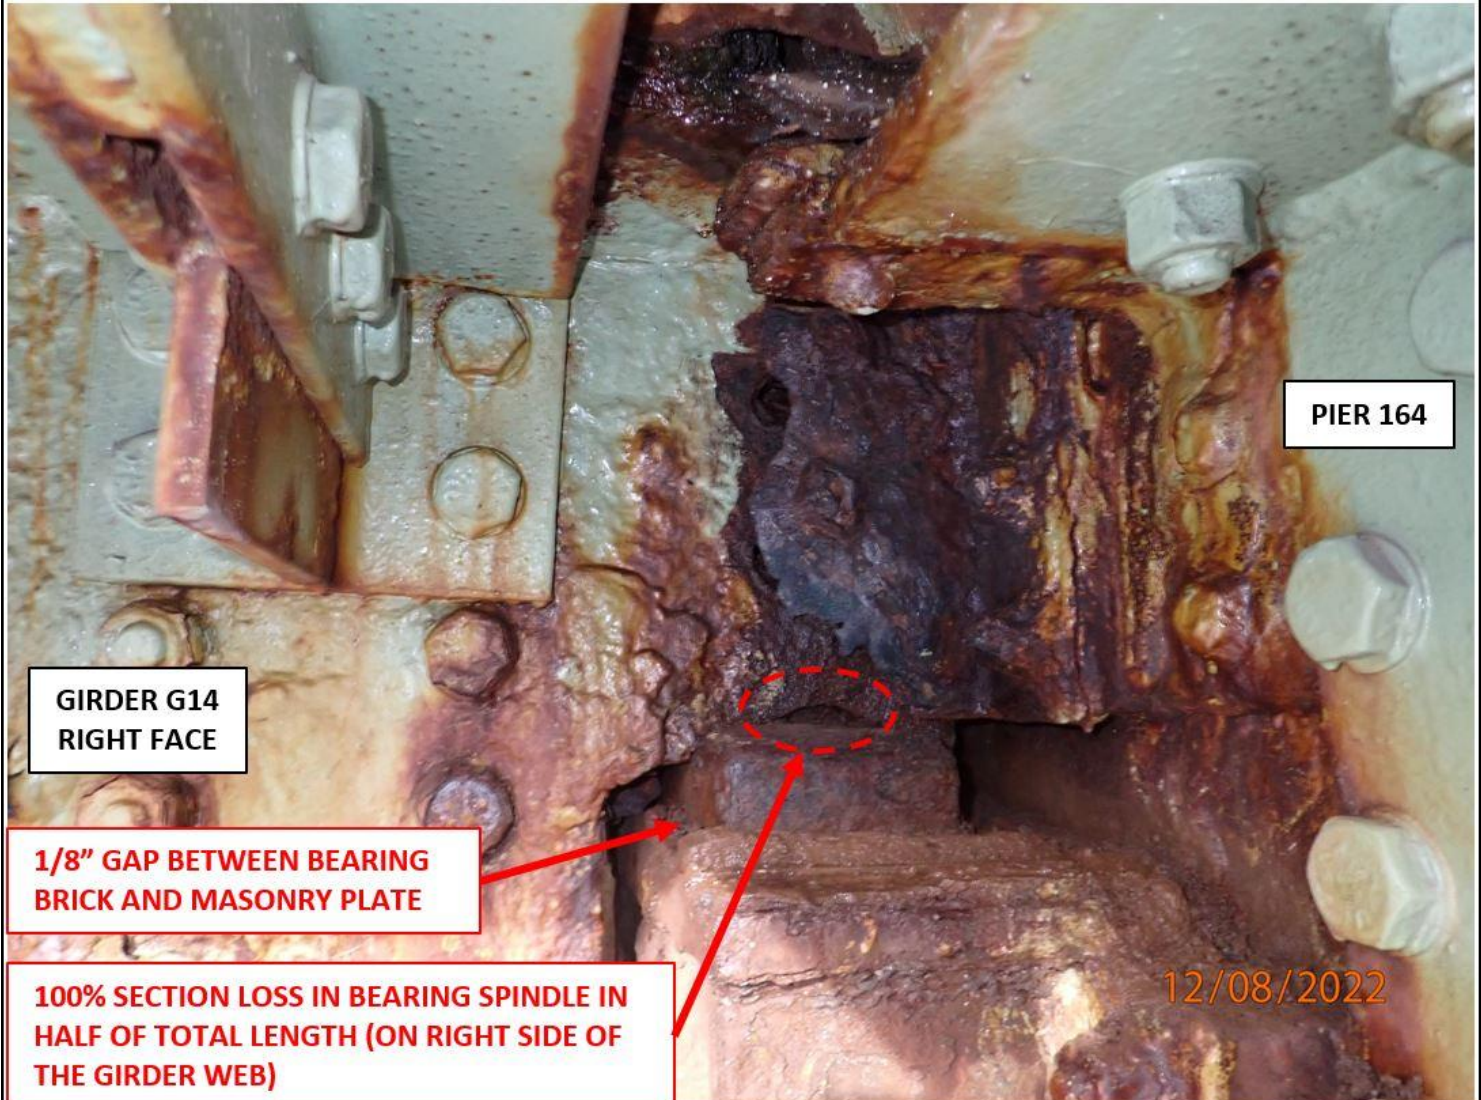
Photo Number: 5

The Girder G14 bearing at Pier 164 exhibits 100% section loss in half of the total length of bearing spindle (in portion located on the right side of the girder web). There is an accumulation of pack rust between the masonry plate and the bearing brick shaped device that creates a 1/8" gap, allowing the bearing device to move laterally upon hammering. Due to the absence of the bearing spindle on the top of the brick shaped bearing device, the girder web is not supported on the bearing.

**Attachment Description:** The Girder G14 bearing exhibits 100% section loss in half of the total length of bearing spindle. There is 1/8" of gap between masonry plate and bearing brick, allowing bearing to move laterally upon hammering. Looking Left.

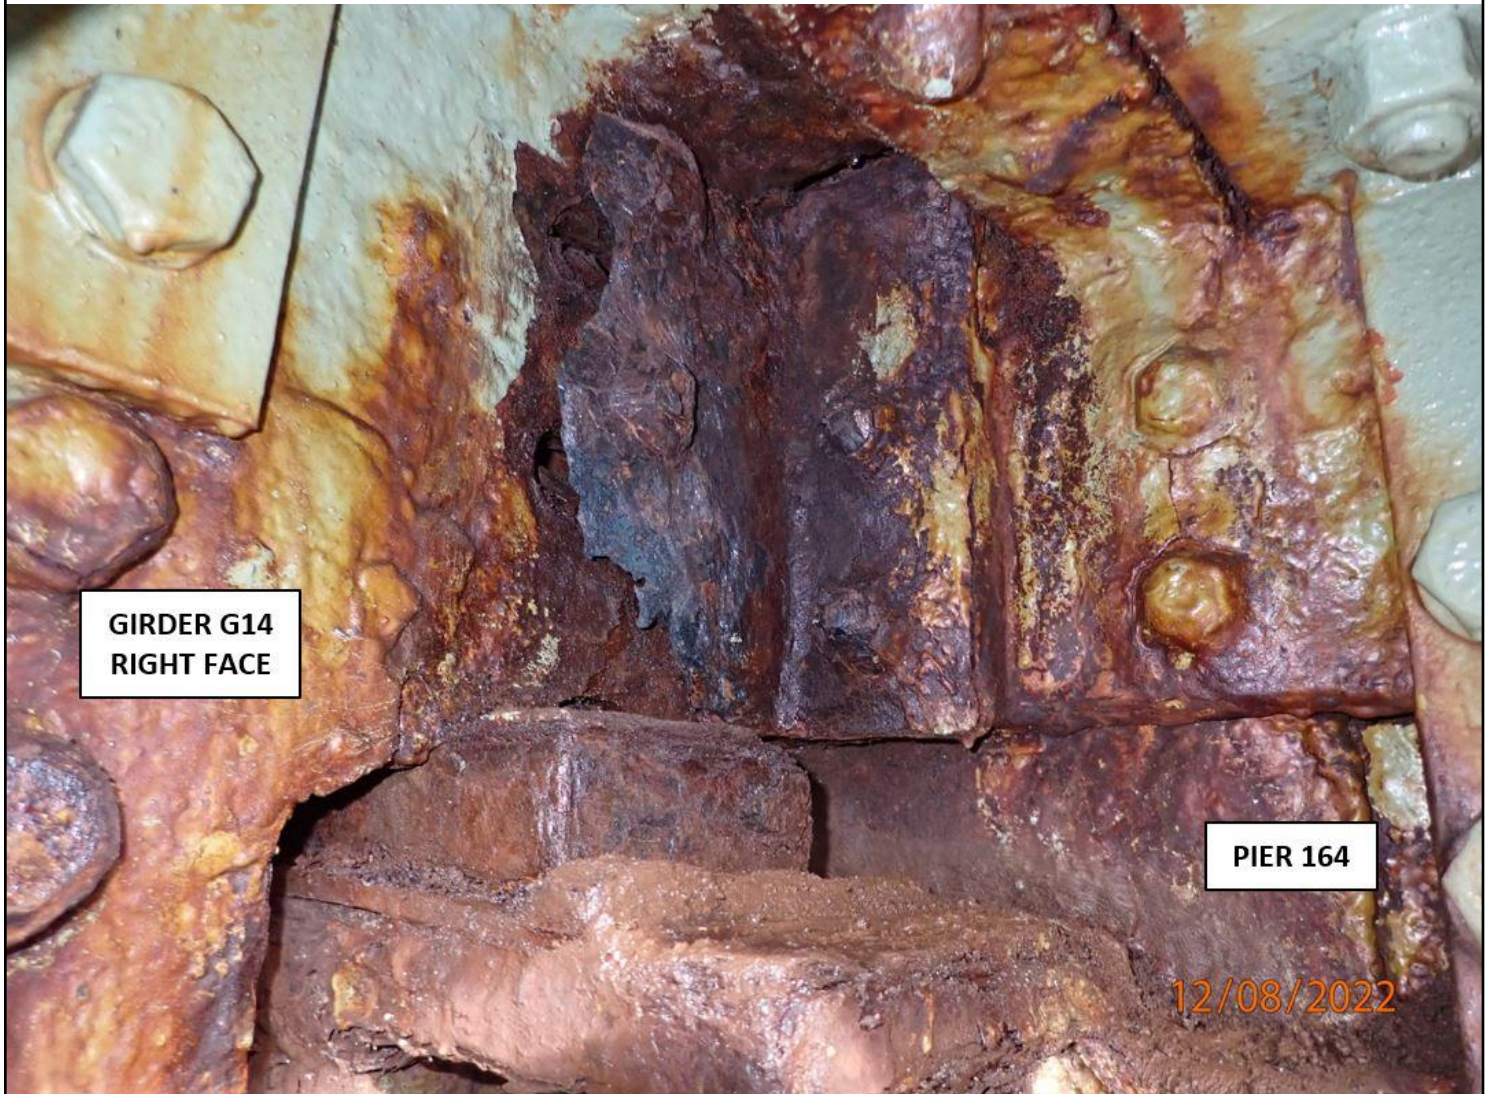
Photo Number: 6

In addition, the girder web above the bearing exhibits up to 1/4" localized pitting (approximately 11% section loss) over an area of 8"W x 10"H and the guide angles on both sides of the girder web exhibits 100% section loss on edges of connecting legs (up to 1-1/2" wide) with up to 90% section loss in remaining surface of the connecting leg. Both bolts in the guide angles are sheared off.

**Attachment Description:** The girder web above the bearing exhibits up to 1/4" localized pitting over an area of 8"W x 10"H. Guide angles on both sides of the girder web exhibits 100% section loss on edges of connecting legs (up to 1-1/2" wide) with up to 90% section loss in remaining surface of the connecting leg. Both bolts in guide angles are sheared off. Looking End and Left.

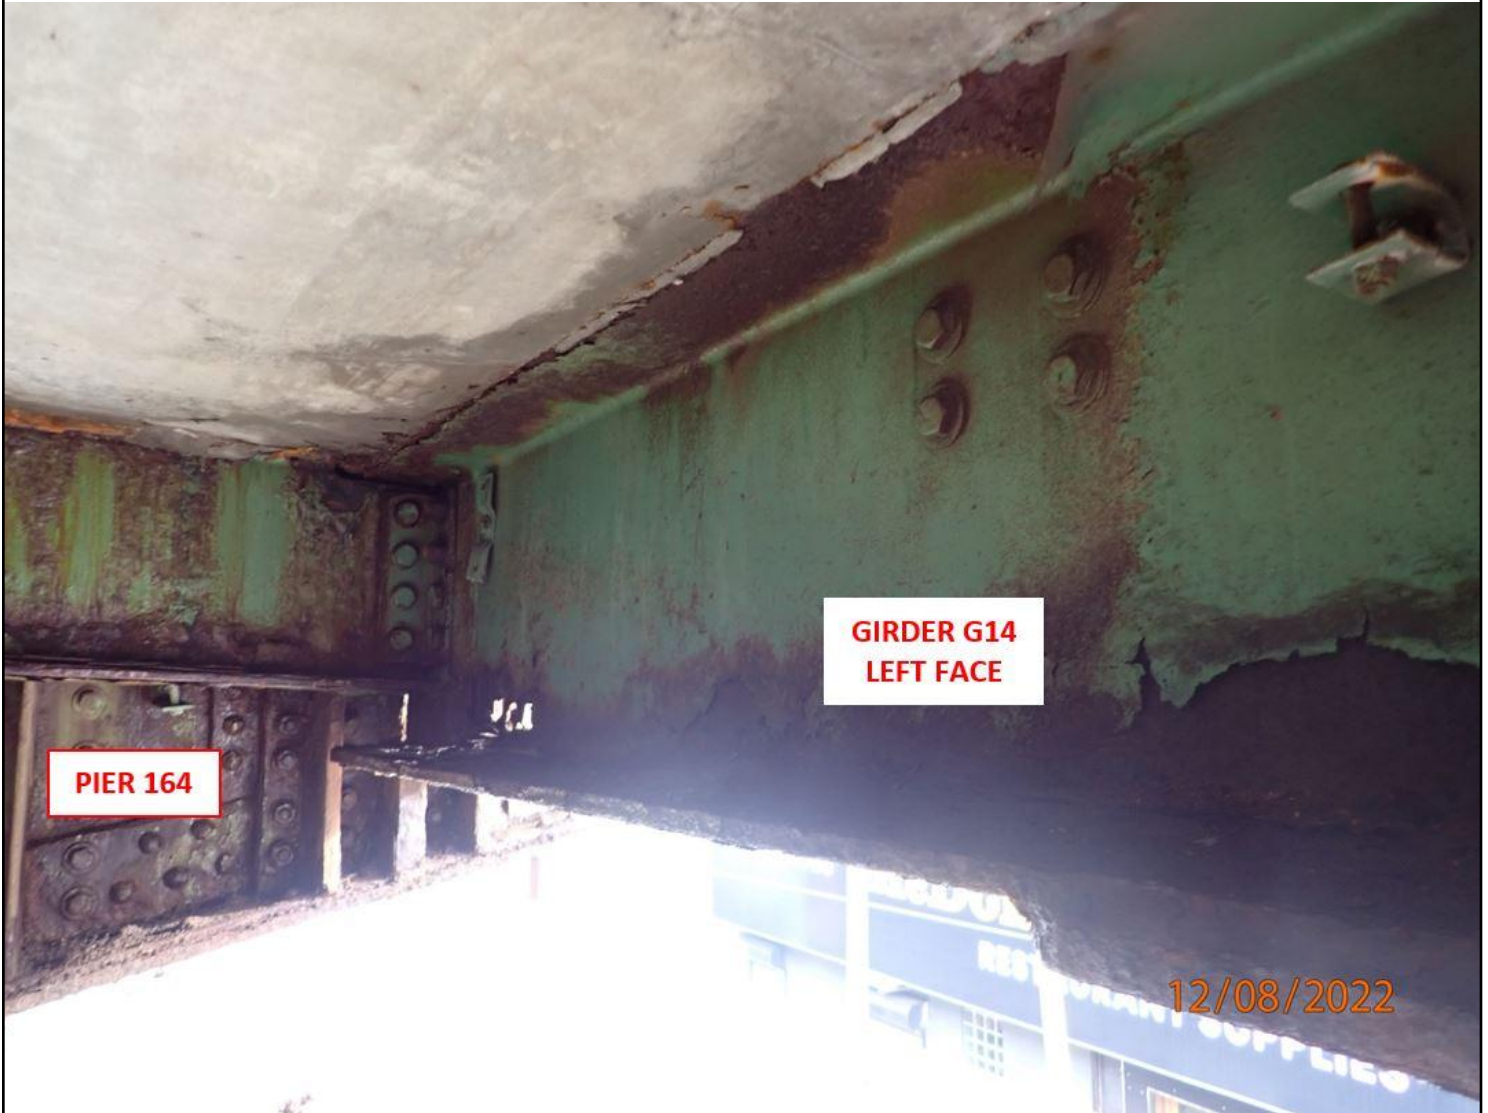
Photo Number: 7

**Attachment Description: General view of Girder G14 in Span 164 at Pier 164. Looking End and Right.**

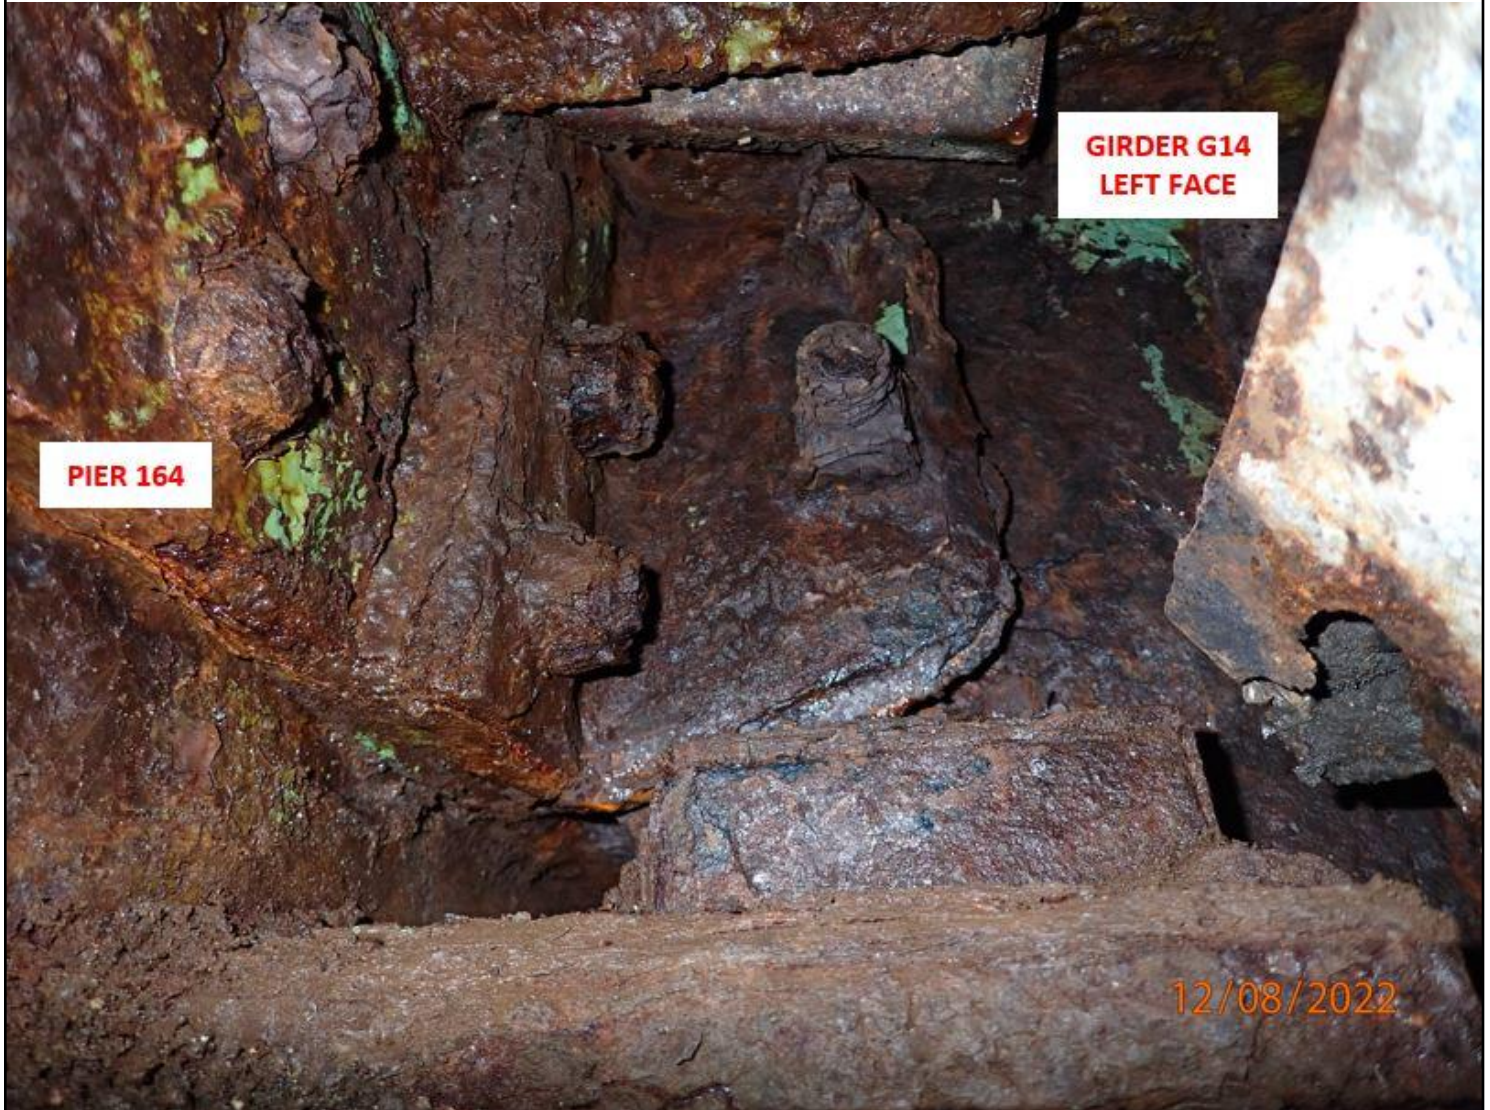
Photo Number: 8

**Attachment Description:** The girder web above the bearing exhibits up to 1/4" localized pitting over an area of 8"W x 10"H. Guide angles on both sides of the girder web exhibits 100% section loss on edges of connecting legs (up to 1-1/2" wide) with up to 90% section loss in remaining surface of the connecting leg. Both bolts in guide angles are sheared off. Looking Right.
